DENT AND GOUGE DEFECTS ASSESSMENT: A CASE STUDY OF GAS PIPELINE

Enefola S. Ameh
Offshore Technology Institute, University
of Port-Harcourt, River State
NIGERIA

Lukeman S. Lawal
Department of System Engineering
University of Lagos, Lagos State
NIGERIA

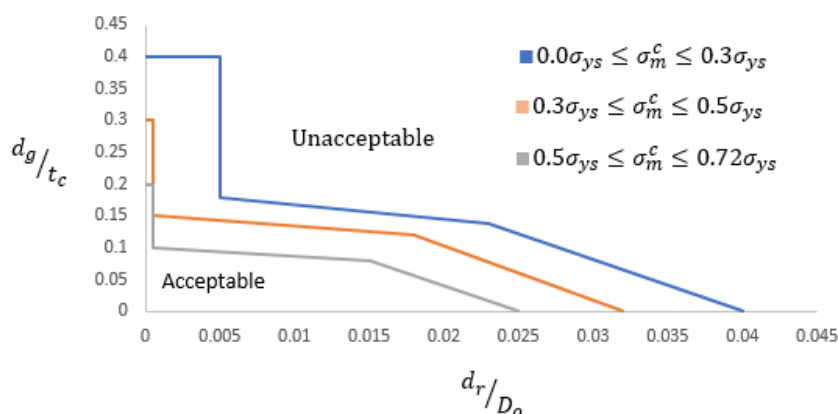
Figure 1: Level 1 Dent – gouge acceptance criteria (AP1, 2009)

Plot of gouge depth to wall thickness ratio against dent depth to component diameter ratio (Fig 1) was used to check Level 1 acceptance criteria for dent and gouge anomalies interaction. The plot showed computed gouge depth to wall thickness ratio (0.15) and dent depth to component ratio (0.0362) intercepted outside the unacceptable region and defined graph boundary. This implied Level I acceptance criteria for engineering critical assessment of the dent and gouge defects interaction was not passed and therefore required next Level of analysis. Level 2 assessment result of the dent and gouge anomalies as shown in Table 4 used remaining strength factor (RSF) which is a quantitative analysis for evaluating acceptance of damage. The Level 2 analysis showed computed remaining strength factor (0.527) was not greater than or equal to allowable remaining strength factor (0.9) indicating violation of the acceptance criteria with mathematical expression as $RSF \geq RSF_a$. Therefore, the Level 2 assessment was not passed. Additionally, remaining fatigue life could not be computed because there is not available analytical or empirical method for predicting fatigue life of dent and gouge interaction anomalies. However, full scale tests showed fatigue life of pipeline would be reduced from order of 105 cycles to 103 when dent contain gouge defect and therefore more deleterious (Lancaster and Palmer, 1996; Fowler et al, 1994). Hence, immediate remediation was to derate the pipeline current maximum operating pressure (6.5MPa) to 3.35MPa using equation (27) and then plan for temporary or permanent repair of the defective segments.
